Little Turkey Lake Aquatic Vegetation Management Plan LaGrange County, Indiana 2007 – 2011

Prepared for:

The Little Turkey Lake Association 3365 S. 1075 E. LaGrange, Indiana 46761

Aquatic Weed Control P. O. Box 325 Syracuse, IN 46567

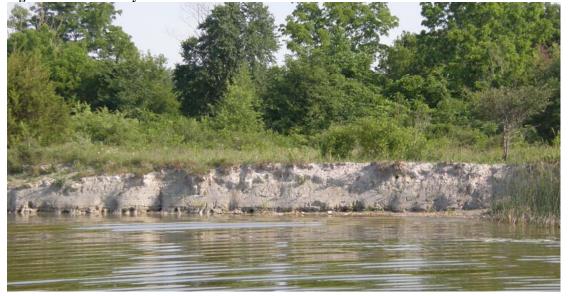
Little Turkey Lake, located in southeastern LaGrange County, has 135 surface acres with a maximum depth of 36 feet and an average depth of 11.5 feet. According to Harza Engineering Hydraulic Retention time is approximately 17 days. Little Turkey Lake was created in the early 1900's when a cement manufacturer dredged marl from a wetland which is now the lake (Harza, 2003). This dredging could account for the rugged, uneven shoreline in many areas of the lake (Figure 1).

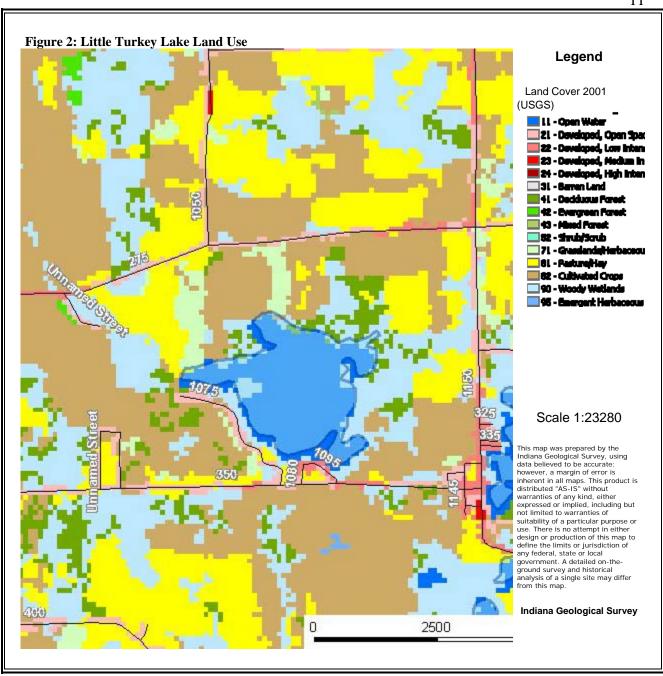
Little Turkey Lake lies on Turkey Creek, which drains into the Pigeon River. Little Turkeys watershed has an area of 32, 282 acres. In 1990, it was estimated that 20, 831 of these acres were used for crop production. Figure 2 shows 2001 Land Uses around Little Turkey Lake.

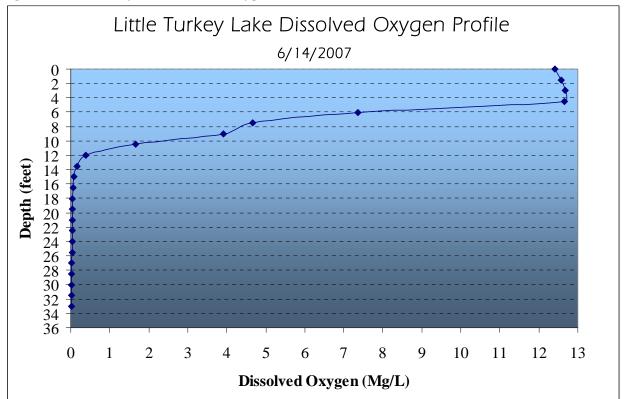
Figure 3: Little Turkey Lake Dissolved Oxygen Profile

In June, Little Turkey Lake already showed strong stratification. Oxygen levels remained constant down to a depth of only 5 feet. After 5 feet, dissolved oxygen dropped rapidly, with almost no oxygen being present in the water column at a depth of 12 feet (Figure 3).

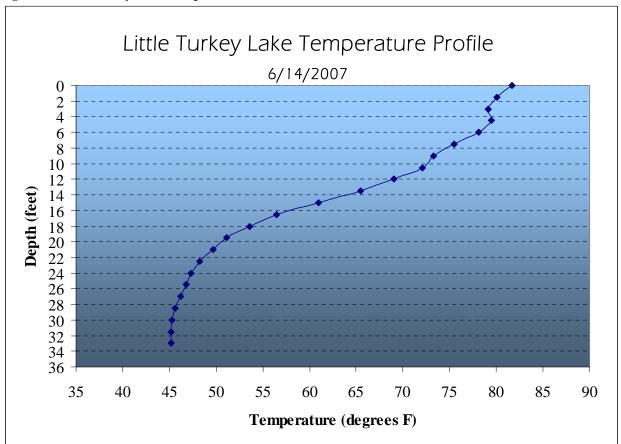
Figure 4: Little Turkey Lake Temperature Profile

The metalimnion is the transition zone between the surface water and the deep water. It is usually accompanied by rapid changes in dissolved oxygen and temperature. The metalimnion in Little Turkey Lake was between 6 and 18 feet, characterized by a loss of dissolved oxygen and a decrease in temperature.

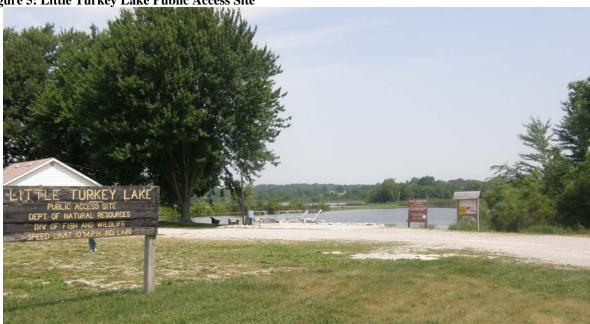
Figure 5: Little Turkey Lake Public Access Site

Little Turkey Lake receives moderate high levels of public use during the summer months. Little Turkey Lake has an IDNR public access site located on the south shore of the lake just off of county road 350 South. This access site has limited parking (7-9 vehicles) but also adds to the number of boats using the lake. Figure 5 shows the Little Turkey Lake public access site.

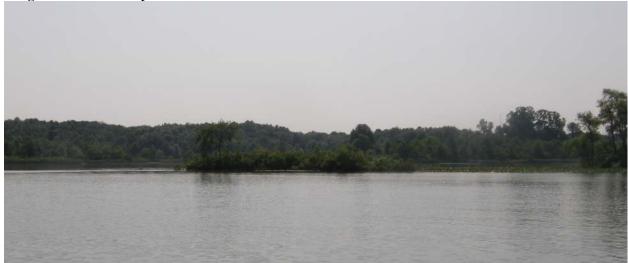
Little Turkey Lake has a 10 mile per hour speed limit, which helps limit excessive boat traffic and excessive speeds. The lake is unique in that only about a third of the lake is developed. The lake has several small islands, and a large section of wooded shoreline, especially in the northeast corner of the lake. These attributes, along with the lake's speed limit make it a very peaceful location for fishing and wildlife viewing. Figure 6 shows a portion of the wooded shoreline of Little Turkey Lake.

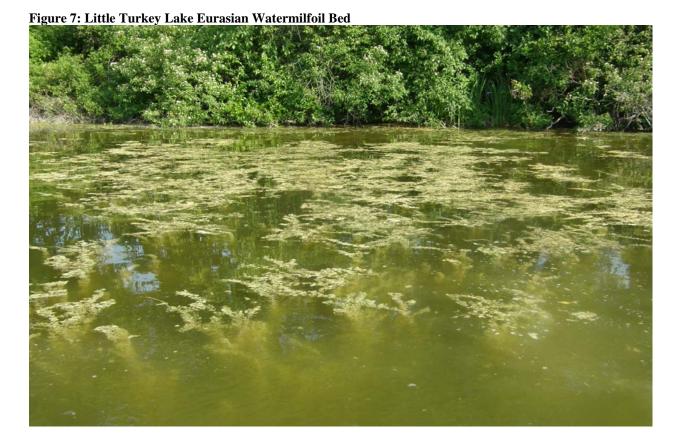
In Little Turkey Lake, Eurasian watermilfoil is found throughout the lake. Site frequency was 36.0% in June of 2007, and 24.0% in August of 2007. The heaviest areas of infestation are near shore, as plants were only found to a depth of 8 to 9 feet in 2007. Eurasian watermilfoil forms very dense beds in many areas of Little Turkey Lake. Figure 7 shows a dense Eurasian watermilfoil bed in Little Turkey Lake.

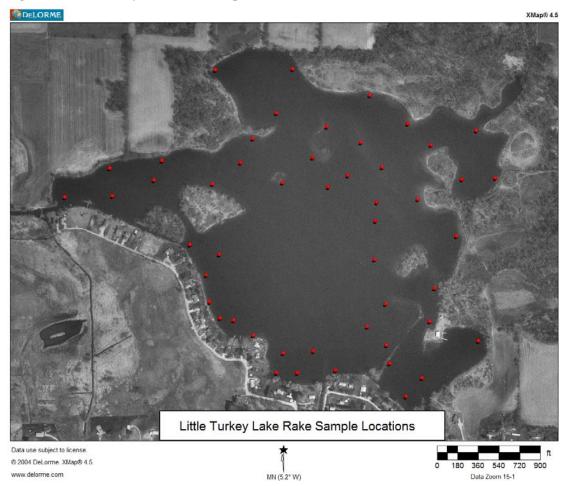
Figure 8: Little Turkey Lake Rake Sample Locations

Two Tier II surveys were conducted by Aquatic Weed Control on Little Turkey Lake in 2007. The first survey took place on June 14, 2007 and the second took place on August 1, 2007. Secchi depth was measured at 3.2 in both the June and the August survey. Nine plant species were collected in June, while 11 plant species were collected in the August survey. Figure 8 shows all rake sample locations for the 2007 Tier II surveys on Little Turkey Lake.

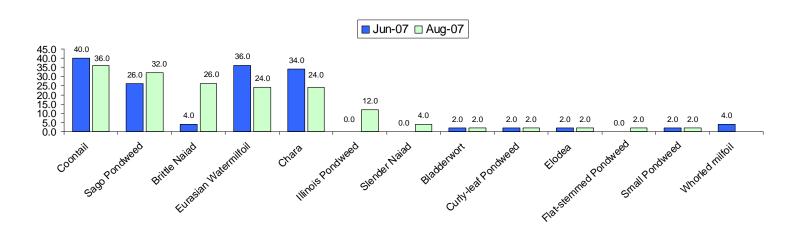
Table 12: 2007 Site Frequencies

Table 12 shows site frequencies for every plant collected in the 2007 Tier II surveys. Coontail was the most frequently collected plant in both surveys in 2007. Eurasian watermilfoil was the second most frequently collected plant and spring, and appeared to show a small amount of natural die off as the year progressed. Chara and sago pondweed, two native species were also collected frequently in both surveys.

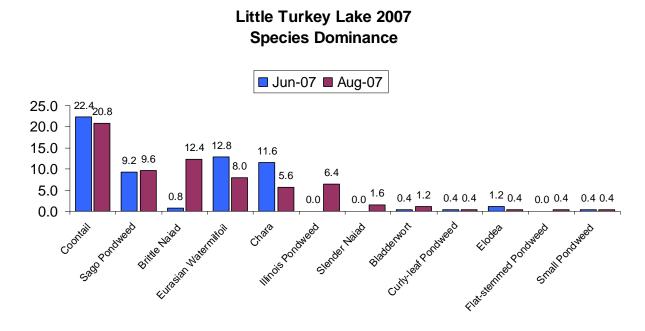
Table 13: 2007 Species Dominance

Table 13 tracks dominance values for each plant collected at Little Turkey Lake in 2007. Trends are similar to site frequency, with coontail being the most dominant plant in both 2007 surveys. Eurasian watermilfoil was the second most dominant plant in both surveys. Illinois pondweed, which was not collected in June of 2007, had a dominance score of 6.4 in August.

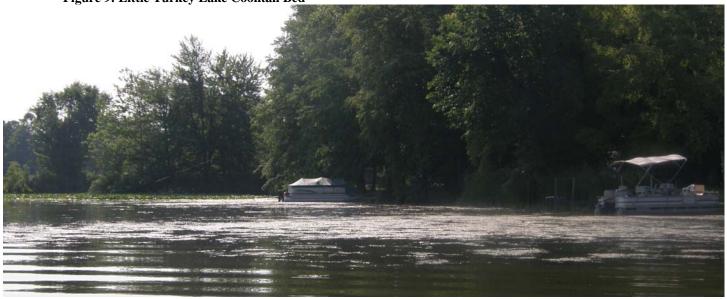
Figure 9: Little Turkey Lake Coontail Bed

Based on 2007 survey results, Eurasian watermilfoil is the main management concern in Little Turkey Lake. Coontail is also very abundant in Little Turkey Lake, but LARE funds will not be awarded for its control since it is a native plant. No matter what LARE treatment strategy is adopted for Little Turkey Lake, coontail will likely continue to cause recreational problems along piers and docks. It is important for lake residents to know that recreational problems from excessive vegetation will still be present after LARE herbicide treatments, and that coontail treatments must be privately funded. Figure 9 shows a dense plant bed dominated by coontail.
